MIO Infusion Set – Penetration Failures

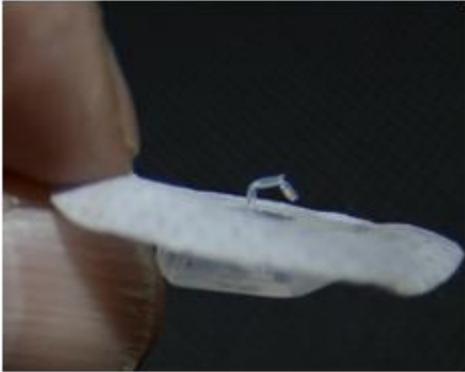
Incident 1

These failures were caused by improper loading of the Mio trigger mechanism.

When loading the Mio spring mechanism, ensure both left and right triggers are engaged. This will ensure the stylus penetrates at a correct 90 degree angle. Below is an example of where the Mio was not properly loaded. Hold the device at eye level and you can quickly check if it is properly loaded. If it isn't, pull it up until both triggers engage and the white top edge of the device clearly level.

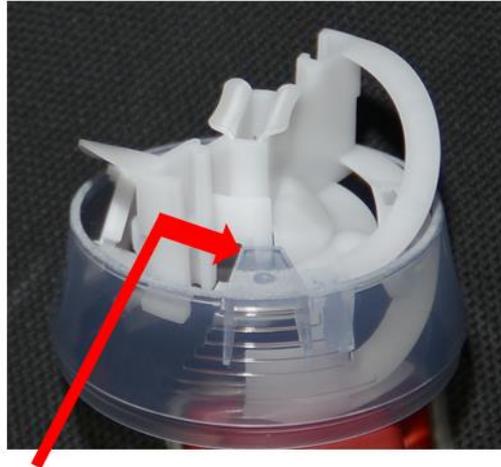
holding tongue not fully engaged

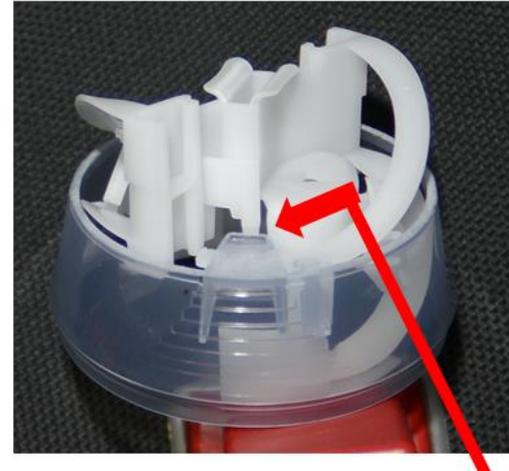
holding tongue fully engaged

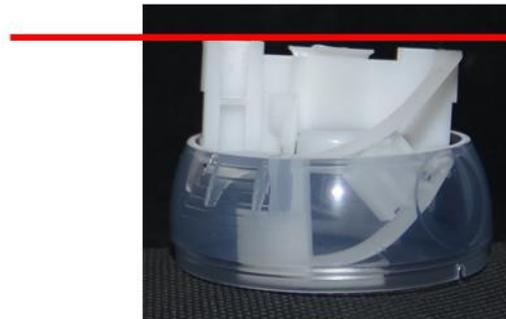
resulting assymetry

Correct this asymmetry by pulling up the lower side until both triggers are fully engaged. Then place on body and simultaneously press the indented release points. This ensures proper stylus angle and entry.
