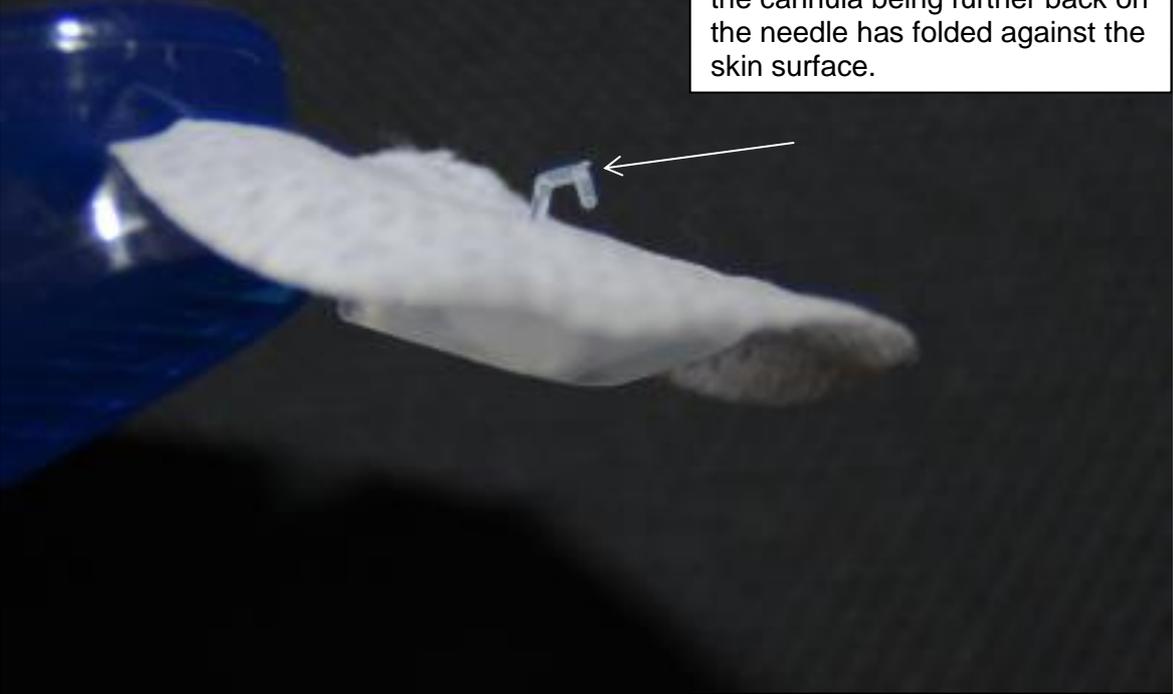
latest incident, you can clearly see in this photo how the needle has penetrated the cannula, and the cannula being further back on the needle has folded against the skin surface.

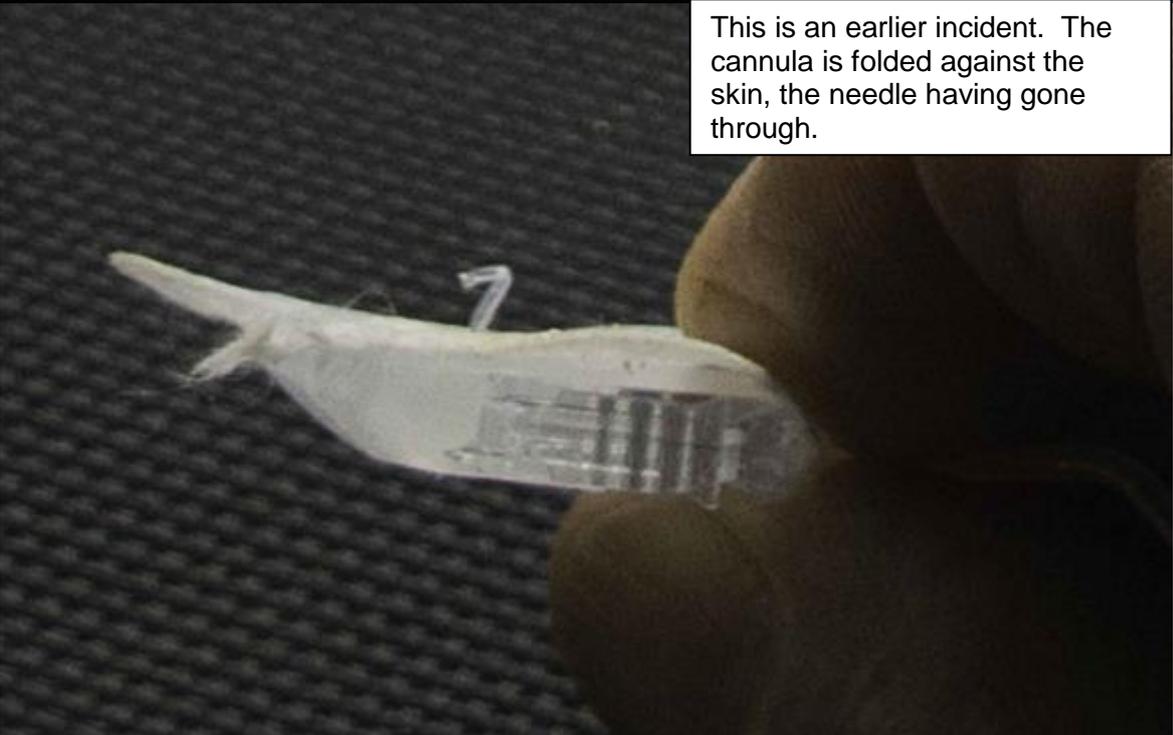
This is an earlier incident. The cannula is folded against the skin, the needle having gone through.
